## dsPIC33CH512MP508 Family Silicon Errata and Data Sheet Clarification

The dsPIC33CH512MP508 family devices that you have received conform functionally to the current Device Data Sheet (DS70005371D), except for the anomalies described in this document.

The silicon issues discussed in the following pages are for silicon revisions with the Device and Revision IDs listed in [Table 1](#). The silicon issues are summarized in [Table 2](#).

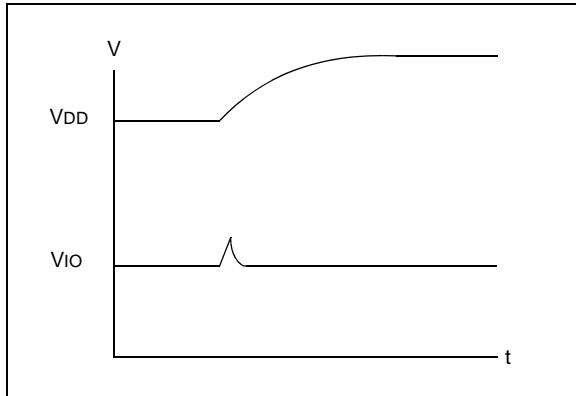
**FIGURE 1-1: I/O RAMP**

During a fast device power-up, when the VDD ramp is less than 4 mS, the I/O pins may drive up to 100  $\mu$ A current for a duration of up to 10  $\mu$ S (Figure 1-1).

Example applications affected may include complementary power switches, where a transient current shoot-through might occur. High-voltage applications with complementary switches should power the high-voltage 200  $\mu$ Sec later than powering the dsPIC<sup>®</sup> device to avoid the current shoot-through. This behavior is specific to each device and not affected by aging.

1. Slow down the VDD ramp time (greater than 4 mS for VDD to ramp 0V to 3.3V).
2. Ensure the circuitry that is connected to the pins can endure this pulse.
