OMAP3530/25/15/03 Applications Processor
Silicon Revisions 3.1.2, 3.1, 3.0, 2.1, and 2.0

Silicon Errata

Literature Number: SPRZ278F
February 2008–Revised October 2010

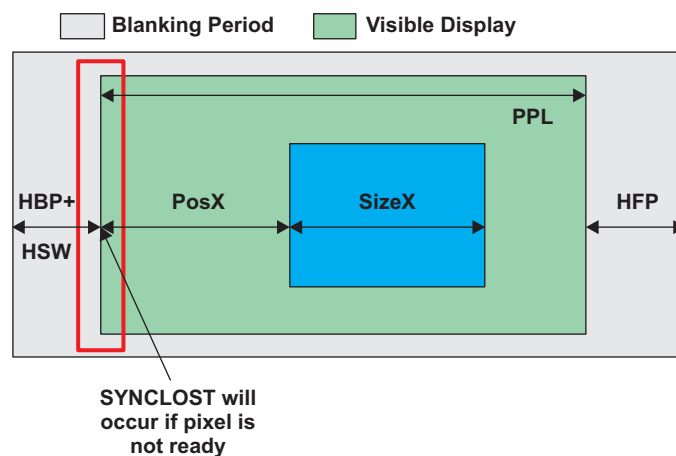
Figure 2. Synclost Interrupt

On OMAP35x Applications Processor silicon revisions 3.1.2 and earlier, Synclost interrupts are observed when performing downscaling and shifting resulting windows on the right of the LCD panel. This interrupt occurs because there is not sufficient time to load the necessary lines buffer before performing downscaling operation. DISPC video pipeline is expected to be ready with the pixels at the end of HSW+HBP period. This limitation is applicable on 3 and 5 taps configurations.

To ensure proper downscaling operation, these conditions should be met:

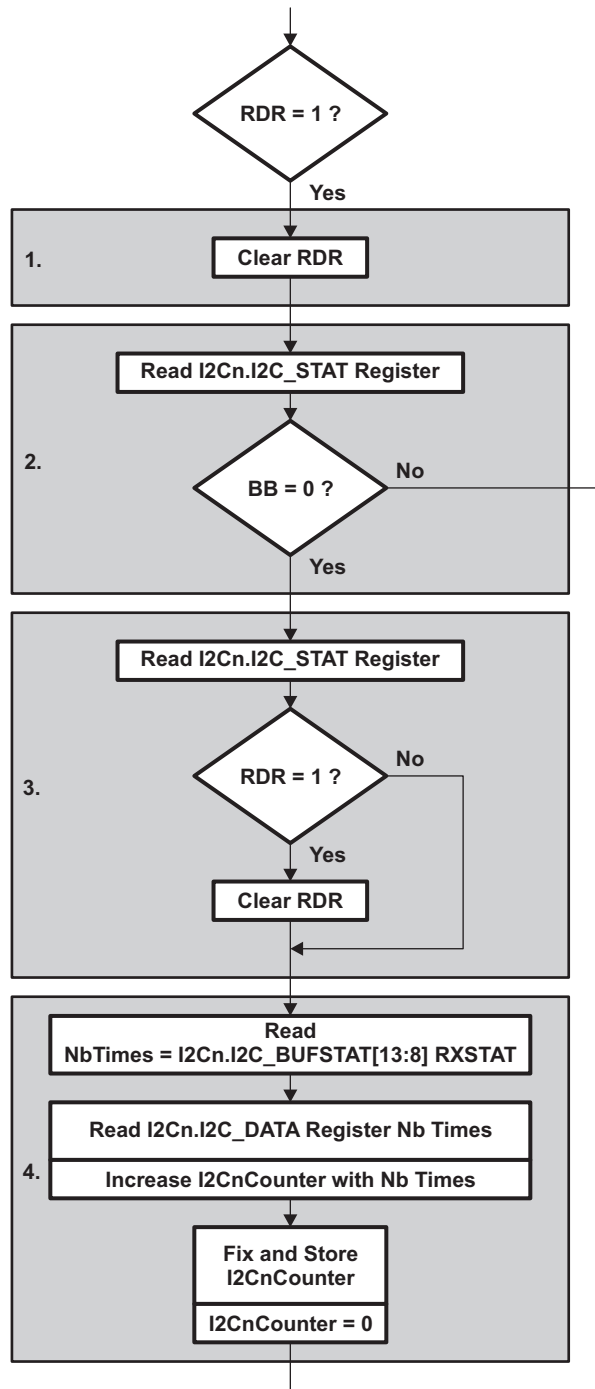
Figure 3. I2C Flowchart

Revision(s) Affected 3.1.2 and earlier**Details** Under certain rare conditions, the I2C_STAT[13].RDR bit may be set as well as the corresponding interrupt fire, even when there is no data in the receive FIFO, or the I2C data transfer is still ongoing. These spurious RDR events must be ignored by the software.**Workaround(s)** Software must filter out unexpected RDR pulses, using the flowchart illustrated in [Figure 3](#) when receiving an I2C RDR interrupt.

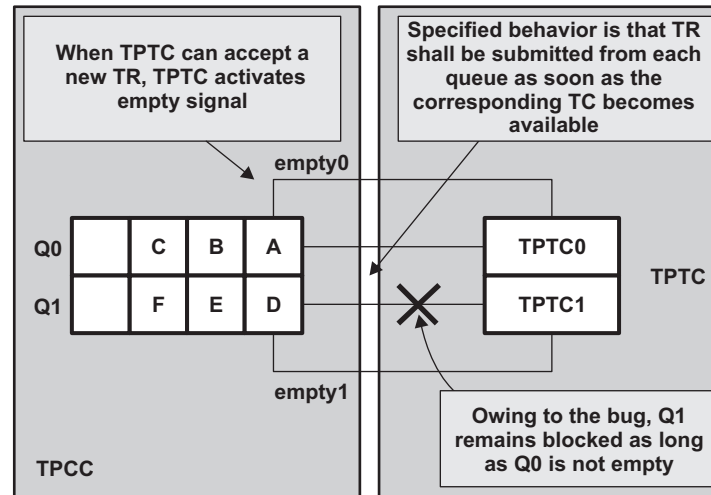
Figure 4. TR Submission Scheme
Workaround(s)

The EDMA channel controller (TPCC) has 2 event queues: Q0 and Q1. Each queue can be mapped to one of the two Transfer Controllers (TPTC): TPTC0 or TPTC1. As explained in the *OMAP35x Technical Reference Manual* (literature number [SPRUF98](#)), the events in each event queue will be extracted as soon as the corresponding TPTC is available for a new Transfer Request (TR) to be programmed into the TPTC. However, due to an issue in the IVA2.2 subsystem, the requests queued in Q1 cannot be submitted to their TPTC as long as Q0 is not empty.

Infrequent short transfers (e.g., latency critical synchronized transfers to/from peripheral) must be placed in Q0, and longer transfers (e.g., block copy) in Q1. For example, when a latency critical transfer is placed in EDMA and a longer transfer in QDMA, the following programming model will minimize the impact of this limitation:

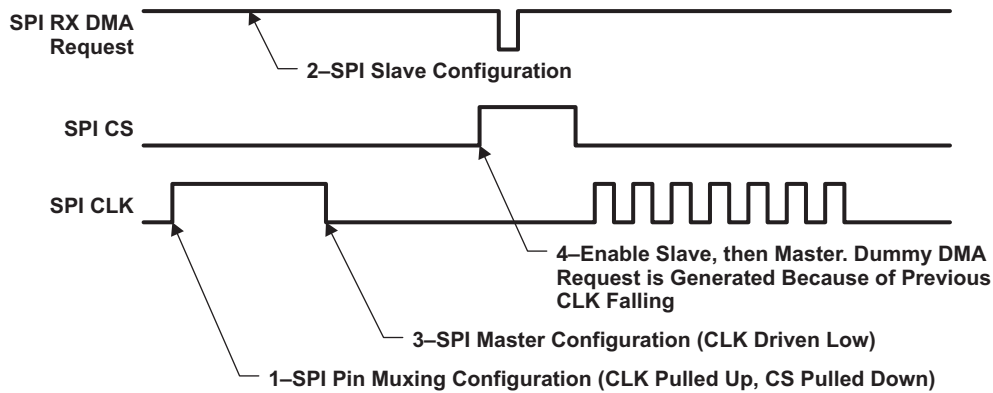
Figure 5. SPI Dummy DMA RX Generation

Details A dummy DMA RX request is generated as soon as the SPI is configured in *slave* mode and a SPI clock edge is detected. The dummy DMA RX request is generated during module configuration, when the module is not performing an SPI transfer. The dummy DMA RX request occurs as soon as the SPI interface signal sensitivity is changed compared to the default value.

The dummy DMA RX request is generated because the mechanism to avoid dummy data capture on a CS glitch is done regardless of channel activation.

Workaround(s) Avoid conditions where the SPI is in *slave* mode and the SPI clock toggles (see examples below).

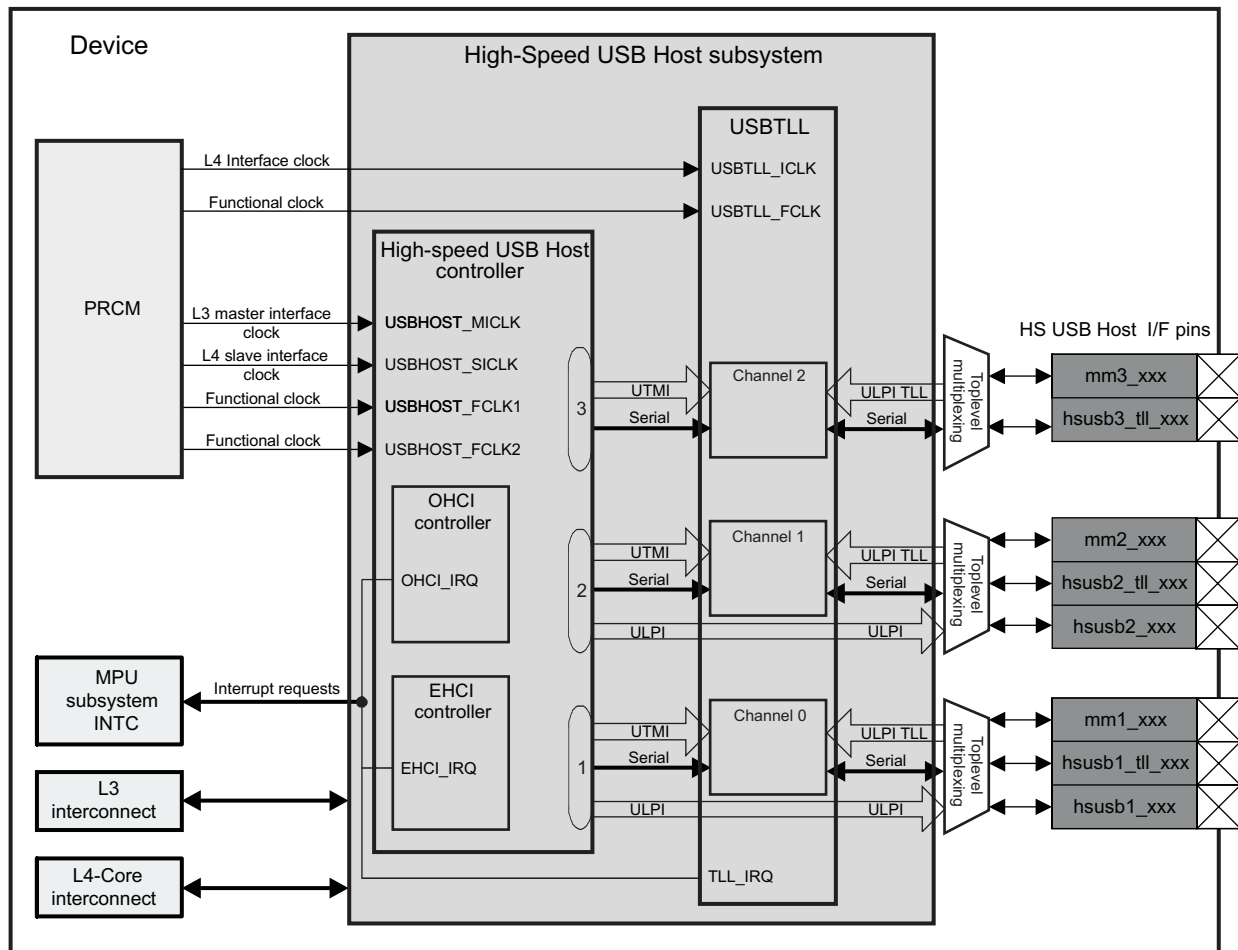
Figure 13. High-Speed USB Host Subsystem Highlight

- On silicon revision 3.0 and earlier, if one port is configured in the ULPI mode, then all other ports must use the same configuration. Therefore, the ports must be configured high-speed mode or full-speed/low-speed mode.
- USB Port 3 cannot operate in ULPI mode; it can only operate in serial or ULPI TLL mode. Furthermore, USB Port 3 is not available in the CUS package.

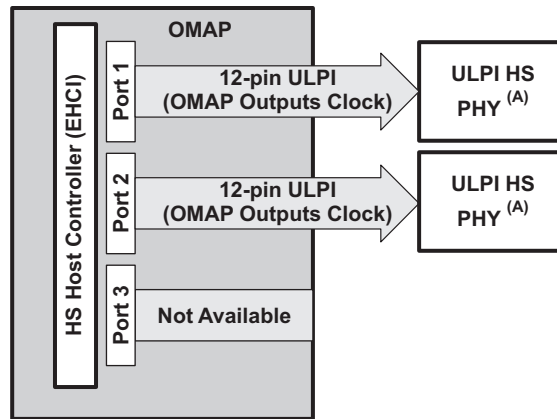
Figure 14. Connecting to High-Speed PHYs Using USB Ports

As shown in [Figure 14](#), USB Port 1 and Port 2 can be used to connect to external high-speed PHYs which include a ULPI port. However, in this case, the external USB PHY must be able to accept a source clock generated by the OMAP high-speed USB controller. Also, in this usage model the USB ports cannot support full-speed and low-speed operation. Therefore, using this approach, USB Port 1 and Port 2 cannot provide a fully compliant USB 2.0 Type-A receptacle; a high-speed USB hub would be required in this case; please see [Figure 15](#).

A. USB port 3 does not support ULPI mode.
Also, USB port 3 not available on CUS package.

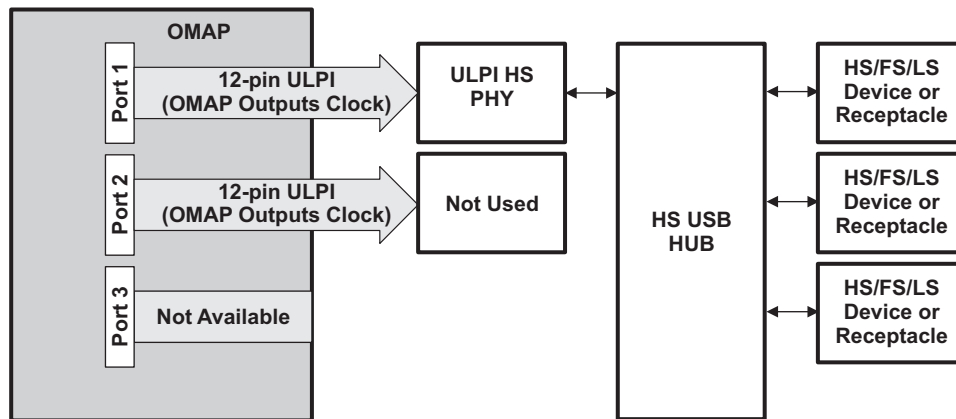
Figure 15. Connecting to a High-Speed USB Hub

A. USB port 3 does not support ULPI mode. Also, USB port 3 not available on CUS package.

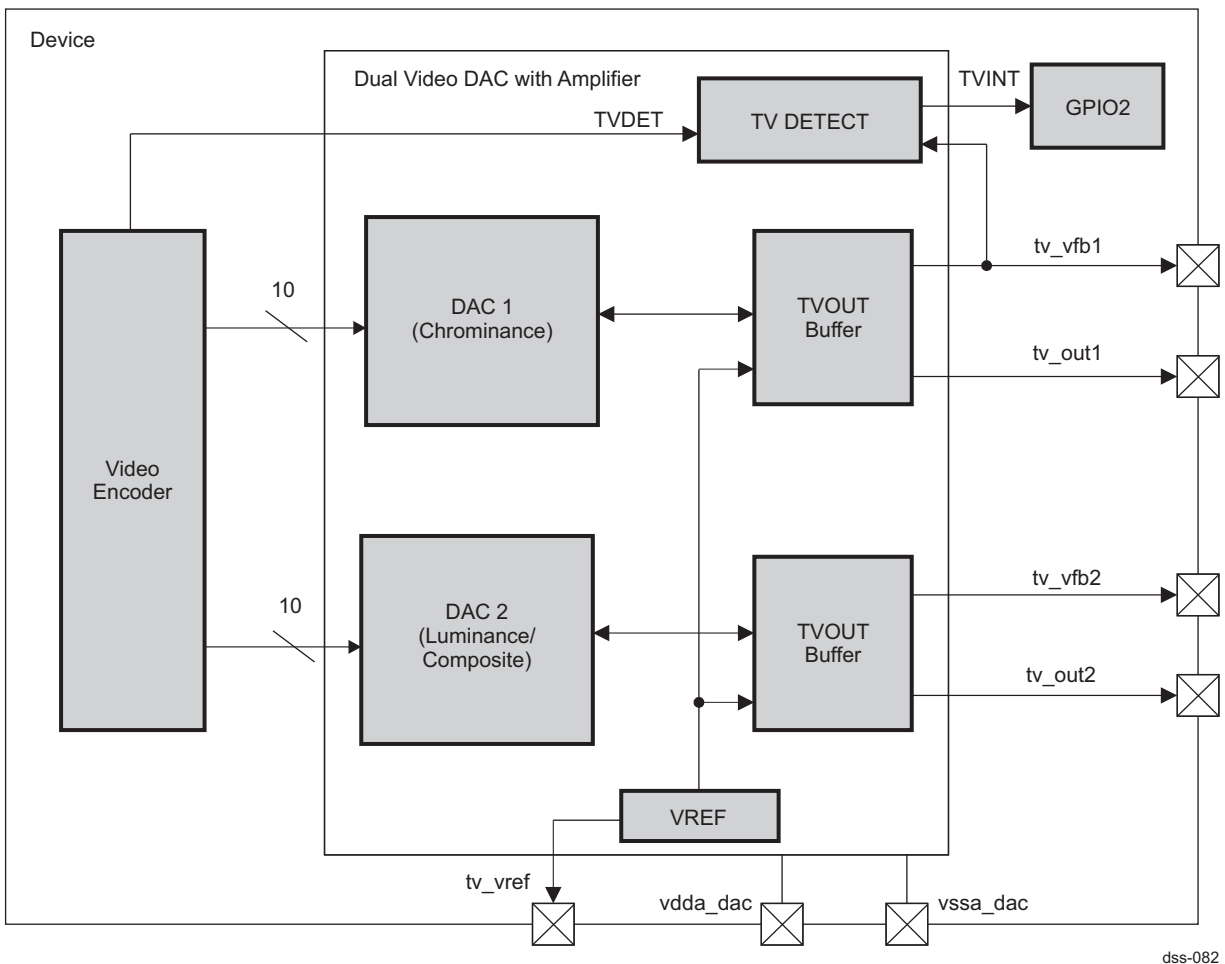
Figure 16. DAC Implementation

Furthermore, for proper TV detection in composite video mode (CVBS), DAC1 should be used for luminance and DAC2 for chrominance. Therefore, as a direct consequence of implementation, the TV detect feature is not available for composite video mode.

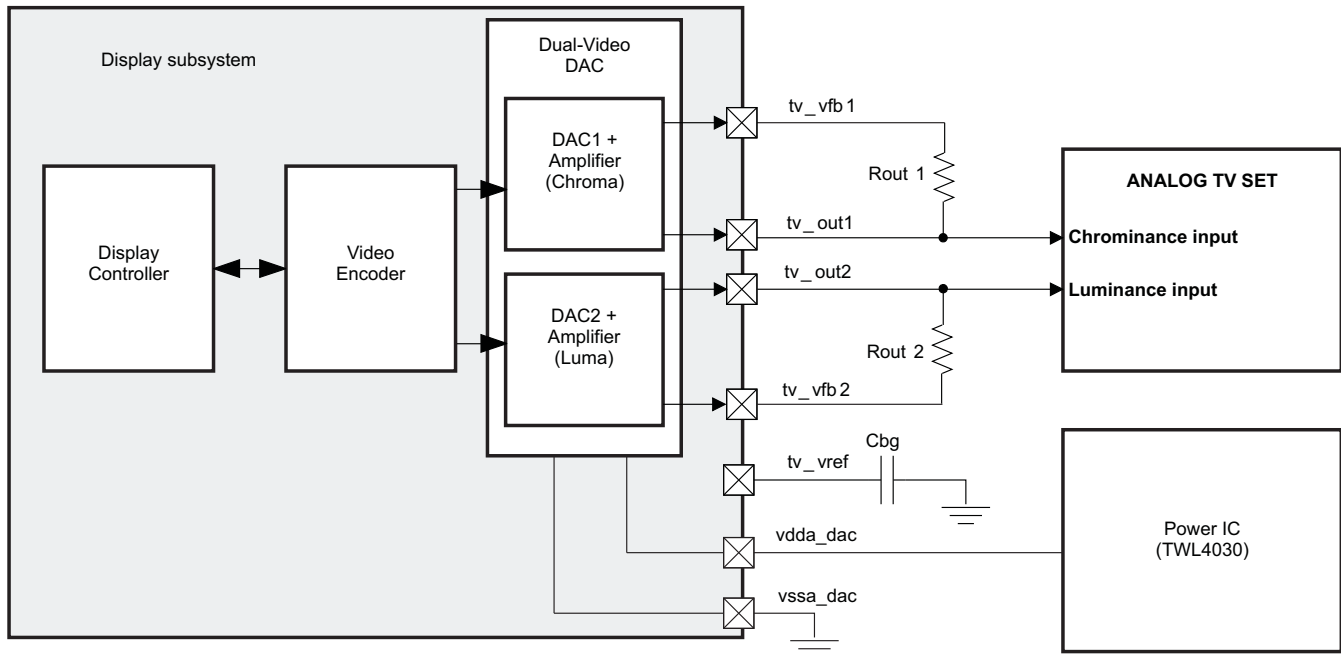
Figure 17. External Connection to TV Set

There is no workaround for the TV detect functionality. This feature is unavailable in *composite* video mode.

For proper TV out functionality, the external connection to the TV set must follow the implementation shown in [Figure 17](#).
